PROYECTO DE RESTAURACIÓN  
DE UN TRAMO DEL **RÍO**  
**JARAMA** A LA ALTURA DE  
VALDETORRES DEL JARAMA

Jarama River: middle reach  
El Molar (Madrid)

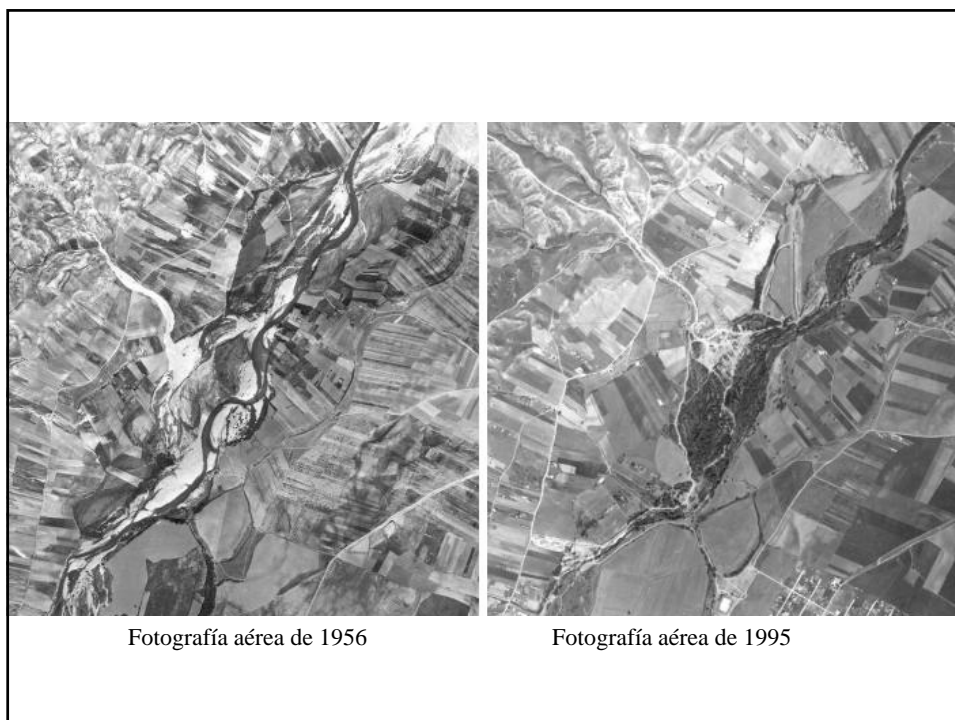
Fotografía aérea de 1956

Comparison between river Jarama reference condition (1956) and actual (1995)

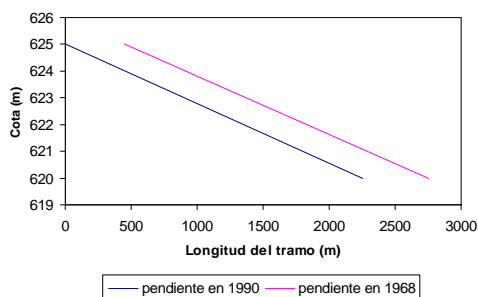
### Longitudinal Profile

River Jarama base level lowered due to:

- Gravel extractions directly from river bed, and also from the riparian system
- Decrease of bed load and transported sediments

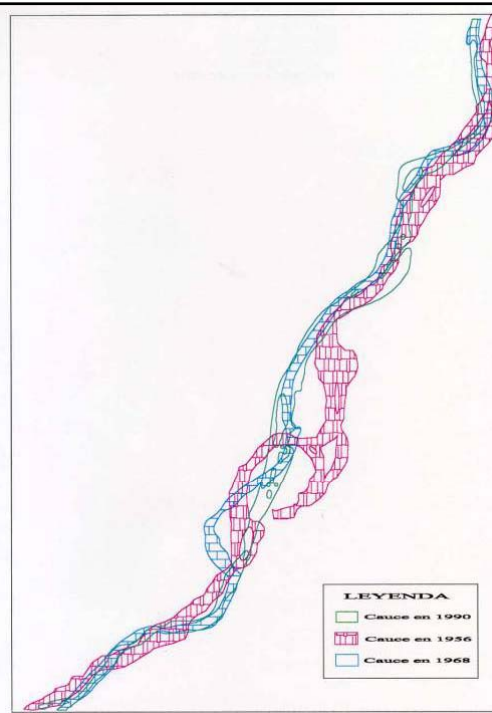
Planta presentada por el cauce en el tramo de estudio en 1956, 1968 y 1990 a través de los planos 1:5.000 de 1990 y 1968 y la fotografía aérea de 1956.

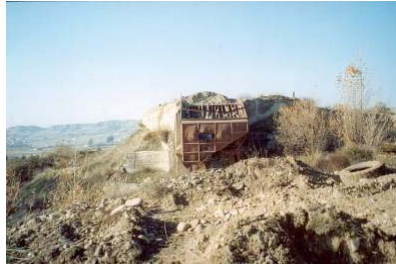
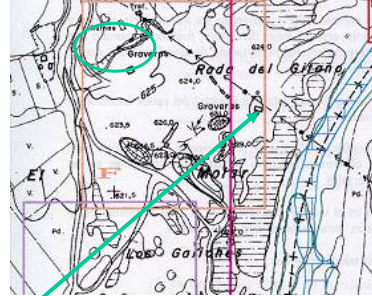
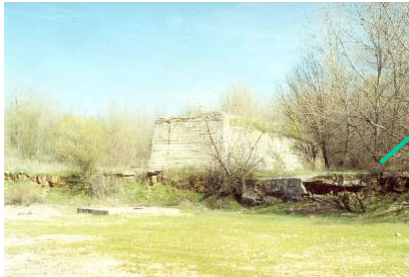
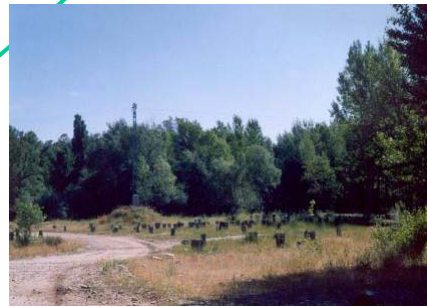
- Remains of gravel industry infrastructure gravera in the riparian zone

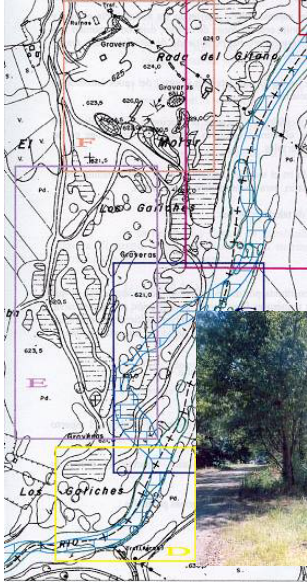
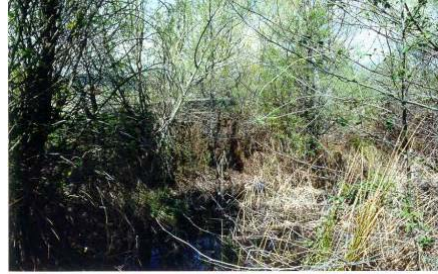
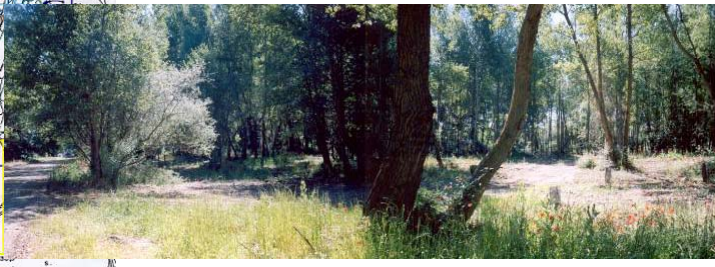
• Presence of many open holes, aisolated by dykes and covered by freatic vegetation

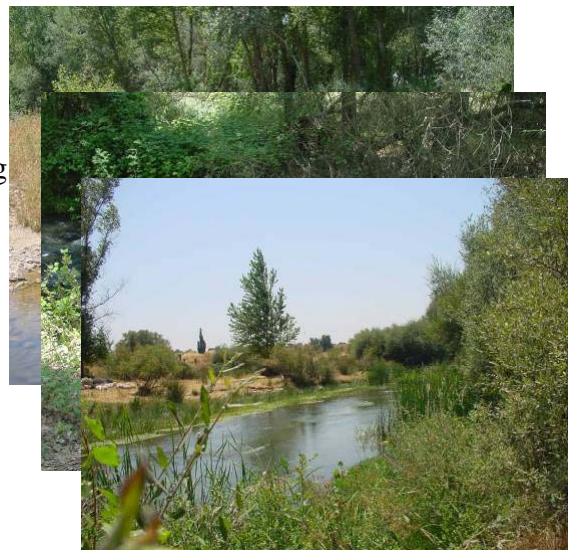
- Eutrophication and water warming below main lagoon
- Fine sediments coming from upstream
- New water outlet
- Flood lamination
- No funds for monitoring results
- Connected Lagoon promoted **non native lentic fish species**
