FINAL REPORT

MONITORING IN THE GEMENC PROTECTED LANDSCAPE AREA: Hydrological, morphological, water quality and ecological monitoring of the Vén- Duna and River Danube between 1997-2000

RIZA, Institute for Inland Water Management and Waste Water Treatment of the Netherlands,
Ministry of Transport, Public Works and Water Management

Project number: RI-2314

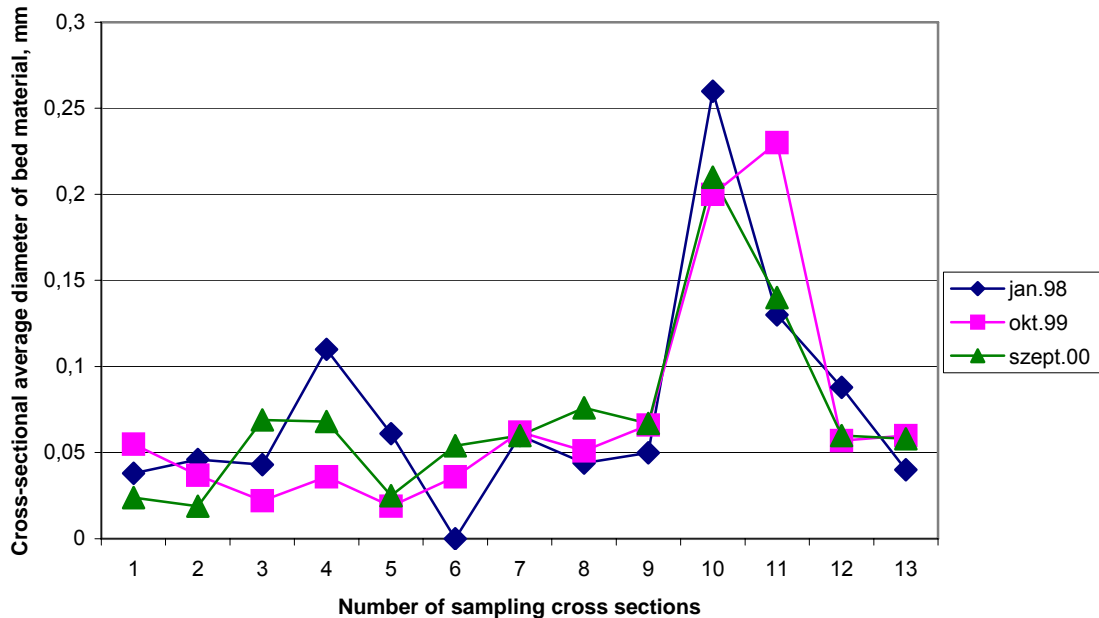
1. The curve connecting the points obtained for the year 1998, preceding the removal of the dam, shows a greater variation in the reach downstream of the dam (cross-sections 1.– 9.) than the graph of the following two years. There is a definite coarsening of the bed material at section 4. and a refinement in section 6. The reasons for these variations could only be found in the knowledge of the flow regime of the investigated and the confluent Danube arms in the years preceding the dam removal.

3. According to the results of the *supplementing samples* taken from the vicinity of the removed dam in September 1998, the bed material in the section 10. became remarkably finer. This additional data is not to be seen in **Fig. 2.3**. The refinement has continued during the year 1999 and stopped in 2000. It is assumed that the new grain-size composition corresponding to the new, greatly changed flow conditions in the arm has finally established.

8. In October 2000, an overwhelming *depositional tendency* could be observed in section 11. dropping the diameter d50 to 0.14 mm, close to the initial value. A coarse, stable bed material was to be observed in one sample only. The finer material washed out from here has presumably stopped in and around the section 10. This means that the flow velocities increased after the dam removal may transport far downstream one portion of the suspended sediment formerly deposited in the stagnating water body upstream of the dam.

9. The variation of d50 values of bed material from 1998 till 2000 is more moderate along the upper, inflow reach of the Vén-Duna and along the whole reach downstream of section 10.

Figure 2.3. Vén-Duna, variation of bed material d50

As for the first alternative, according to **Fig. 2.3** the bed material temporarily became coarser after the removal of the dam in the reach upstream of it, then the original grain-size composition has been re-established. The latter process might partially be caused by the settlement of certain fractions of the suspended sediment especially during the flood periods in 1999. Downstream of the dam in the longer reach of the arm leading back to the Danube, the originally finer bed-material composition did not change considerably. This means that the continuous through flow could not erode all the fines settled over here during the former stagnant flow regime preceding the dam removal or they were supplemented by recent depositions.

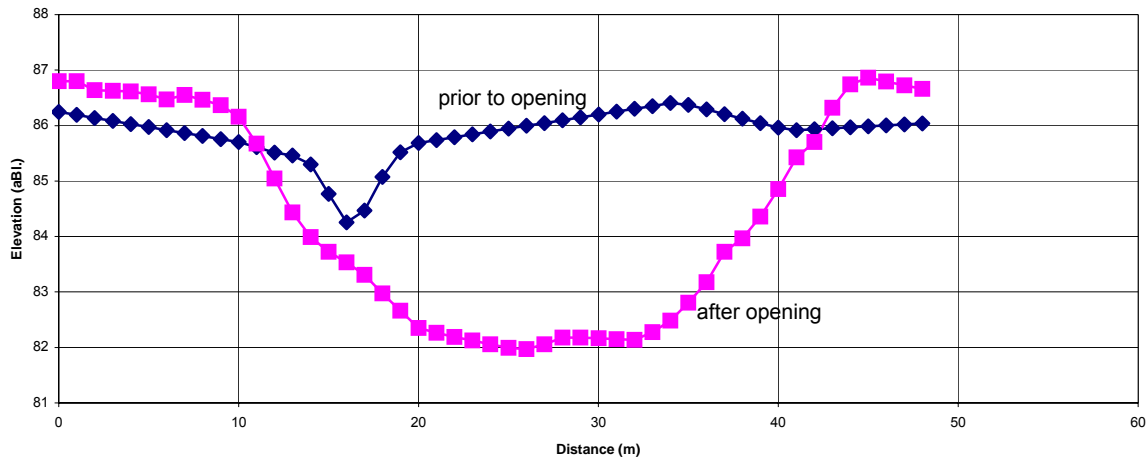
The cross-section at the rock fill gate closing the branch in a 768 m distance from the upstream end is shown in **Fig. 2.4**. The V-shaped depression visible on the gate's crest enabled the passing of fishing boats. Its deepest point is situated at 84.20 m above Baltic Sea level (aBl) corresponding to 320 cm Danube water level at the Baja gauge. It means that before the removal of the dam the through flow could begin at about 2300 m³/s Danube discharge i.e. occurs in 53% of the year. The highest point of the gate is at 86.40 m aBl corresponding to 540 cm gauge height (3650 m³/s, occurring in about 25% of the year).

Figure 2.4. Cross section of the Vén-Duna at the dam

Fig. 2.4. also shows the shape of the dam after the opening, the deepest point of the structure being at 82.0 m aBl. The elevation limiting the through flow, however, is regarded 82.70 m aBl due to the bed level variations along the entrance reach of the arm. This corresponds to a 170 cm water level at the Baja gauge and enables a free inflow to the branch above 1400 m³/s Danube discharges for about 350 days annually i.e. almost the year around (95,9 %).

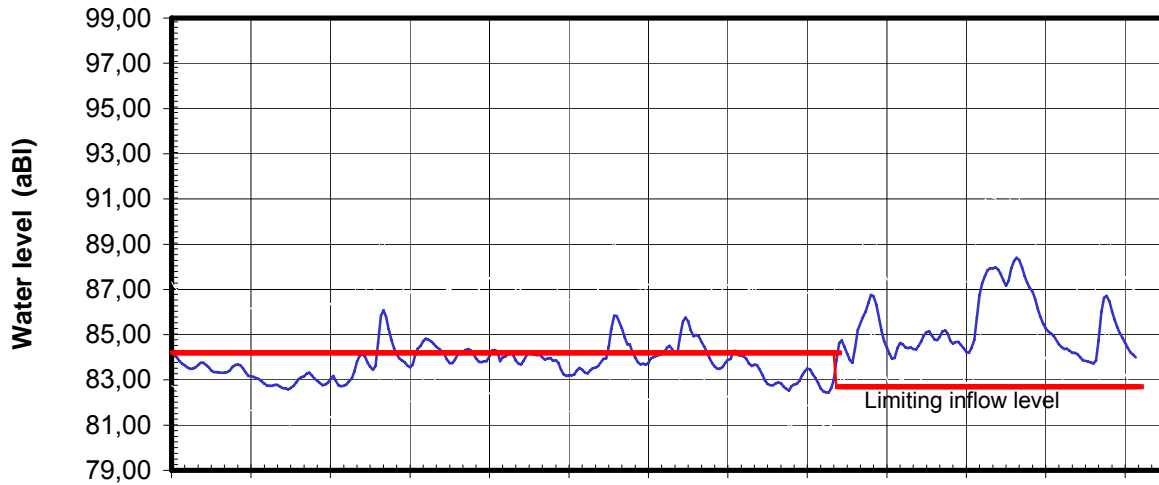
Figure 2.7. Danube at Baja Gauge height time series in 1998 (m aBI)

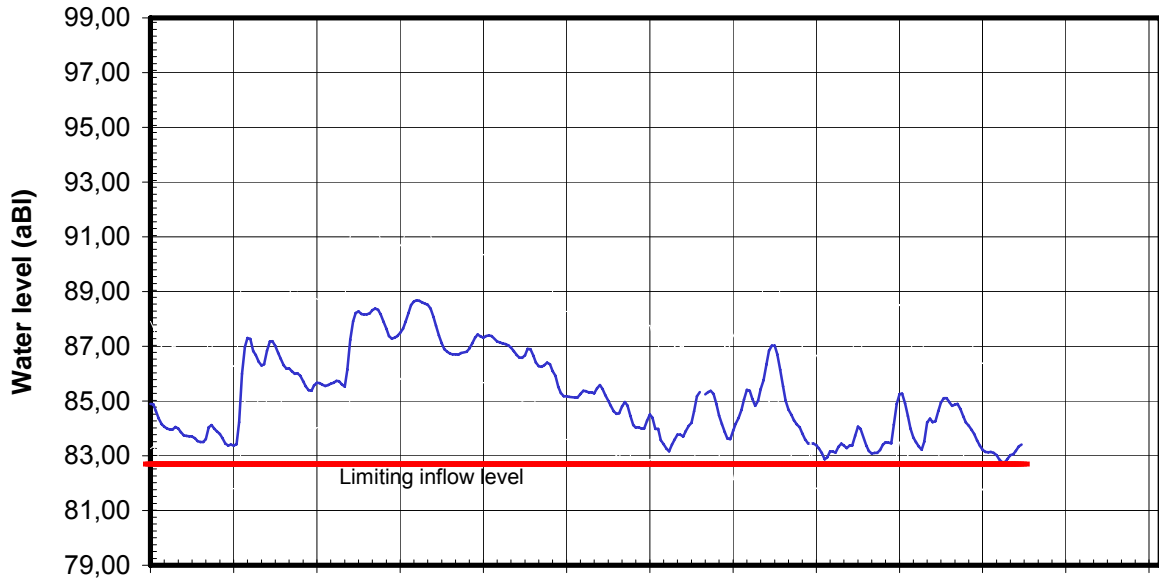
Figure 2.9. Danube at Baja Gauge height time series in 2000 (m aBl)

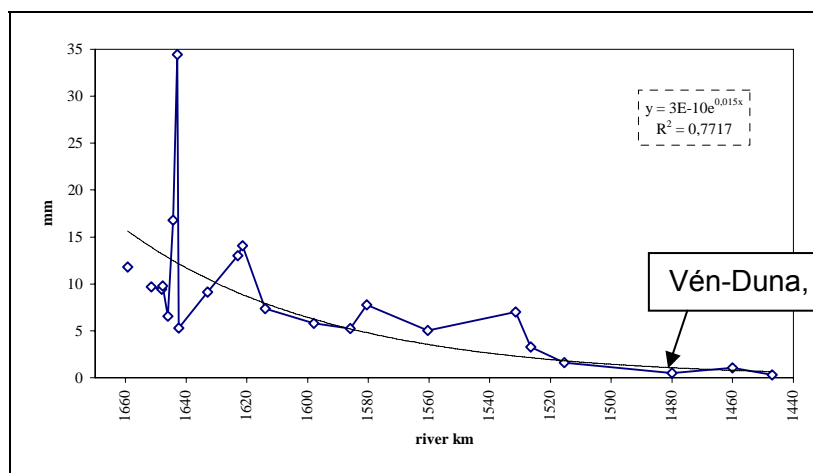
To illustrate the main habitat types of the Lower Hungarian Danube section it is very useful to have a look to the average particle size of the bed material of the river. The average particle size is very small (below 2 mm) downstream Paks (**Figure 3.4**). The main habitat type in this stretch of the river is characterized by sandy bottom in the main Danube arm and predominantly fine sediment in the side arms, respectively.

Figure 3.4. Average particle size of the Danube bed between 1660 (Budapest) and 1440 river km (Mohács)

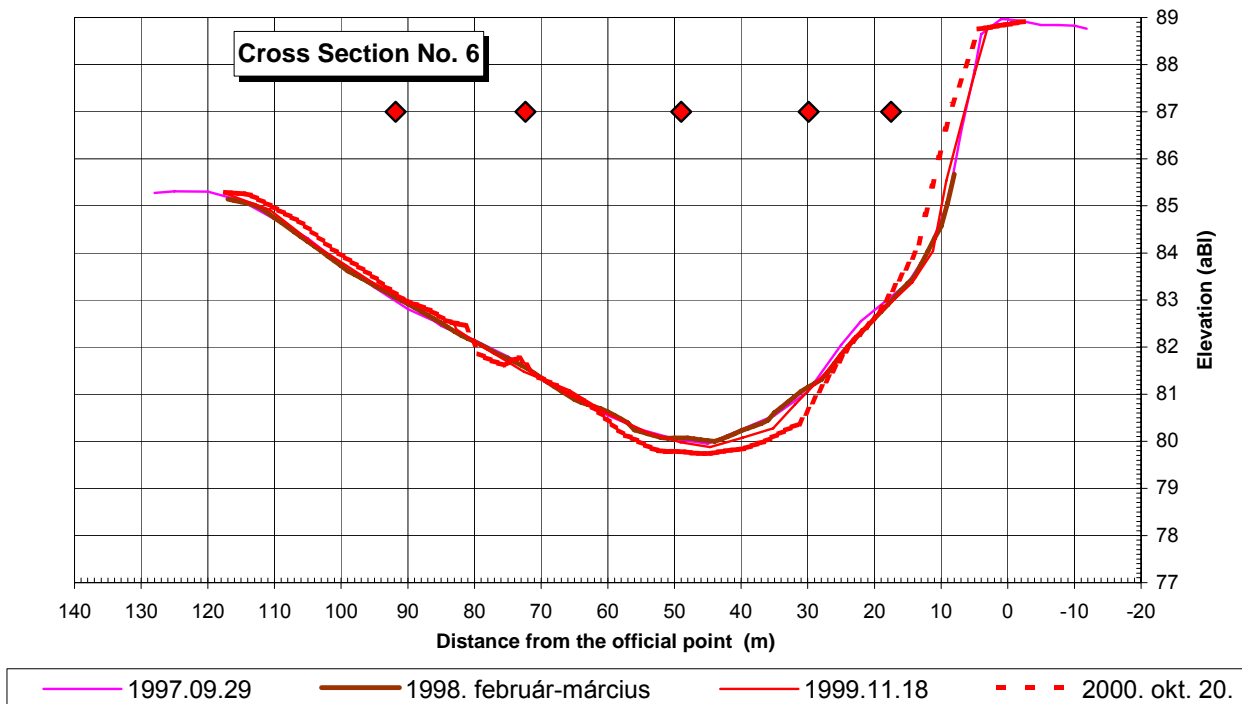
Figure 16. Change of profile in cross section No. 6 between 1998-2000.

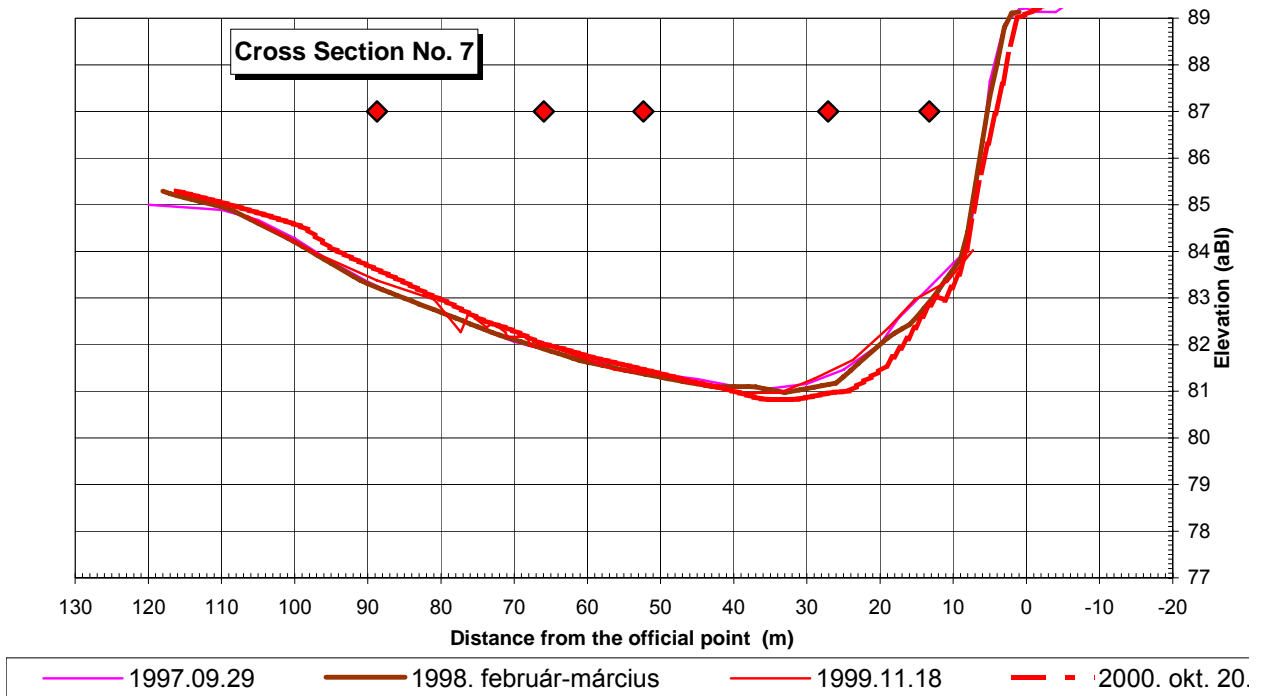
Figure 17. Change of profile in cross section No. 7 between 1998-2000.

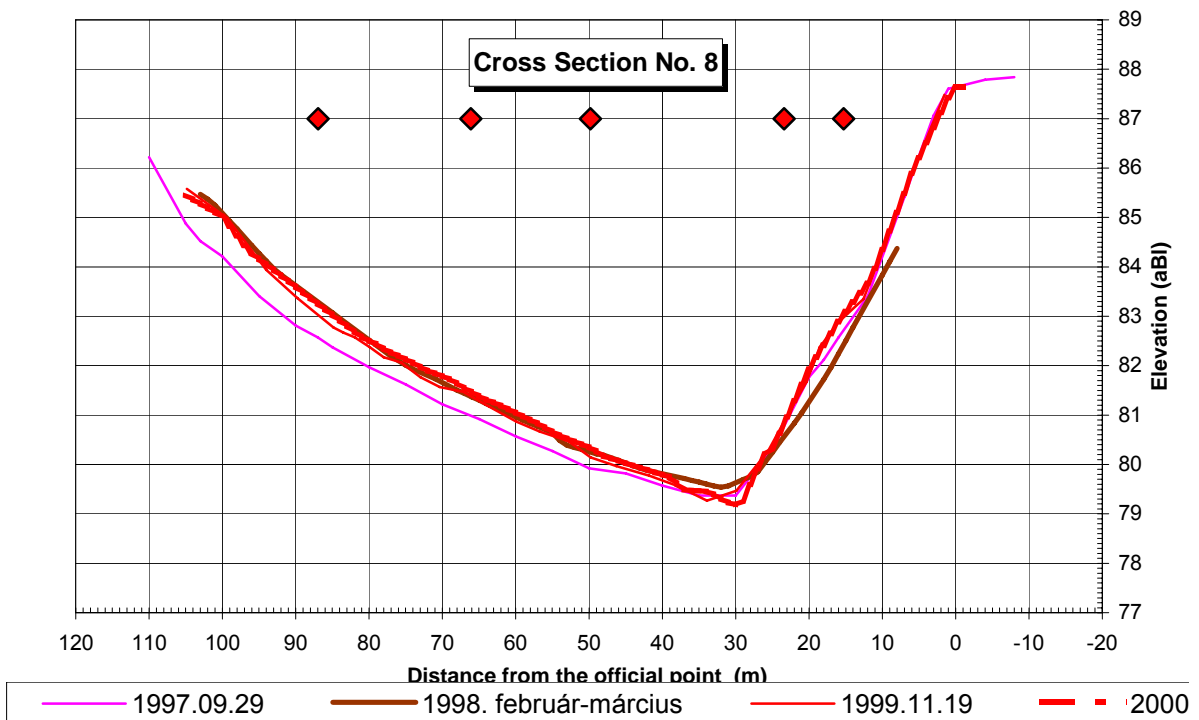
Figure 18. Change of profile in cross section No. 8 between 1998-2000.

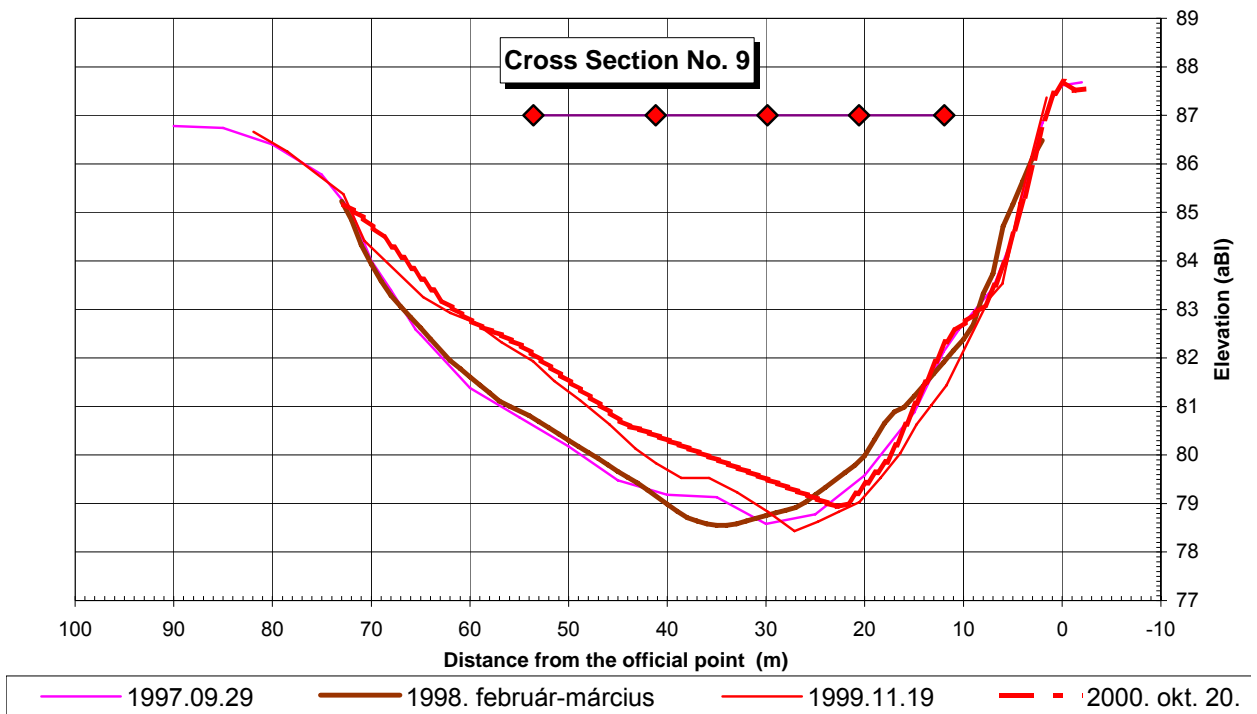
Figure19. Change of profile in cross section No. 9 between 1998-2000.

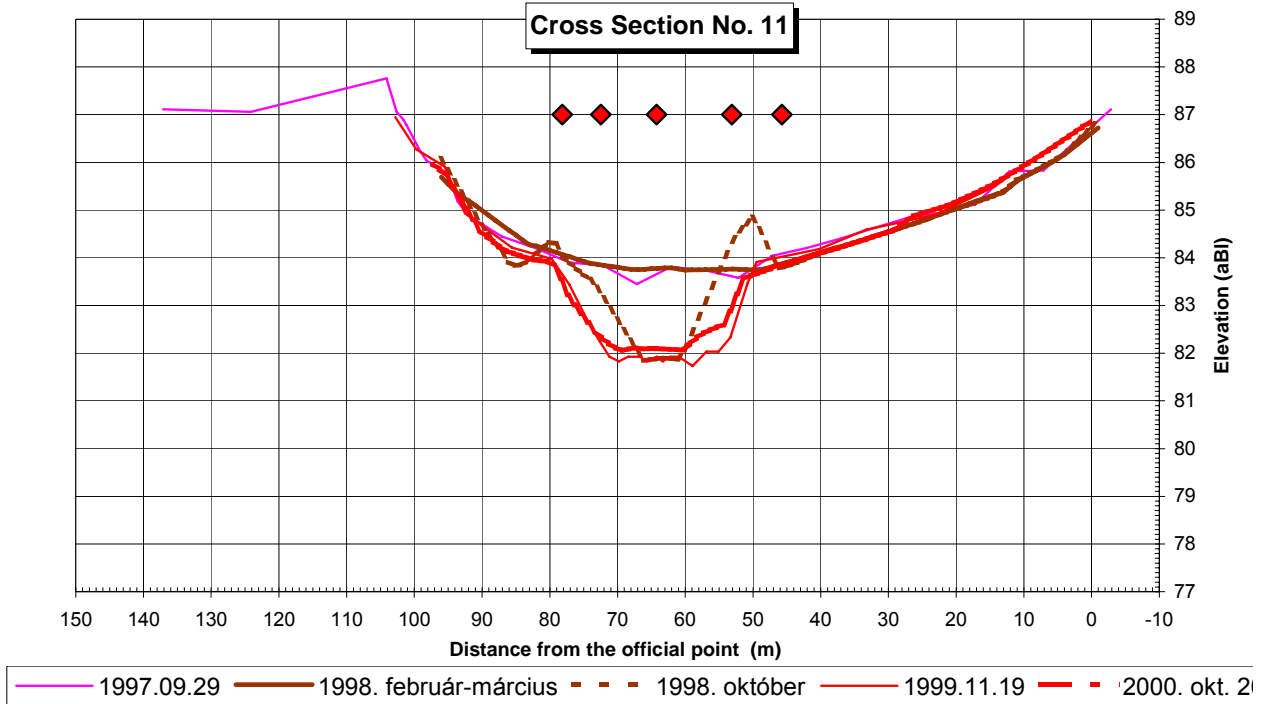
Figure 21. Change of profile in cross section No. 11 between 1998-2000.

A detailed measurement program followed the morphological development in the area. Results show clearly that the main morphological changes were observed in the immediate vicinity of the former rock dam (Section 10 and 11, **Figures 20, 21**). Not too far upstream the dam the channel became deeper due to the narrow digging of the riverbed and later bed erosion. Extended deposition of the sediment took place below the reopened section. High floods with increased sediment transport capacity carved the upstream and downstream sections depositing huge amount of sandy bottom sediment just after the relatively narrow reopened rock dam.

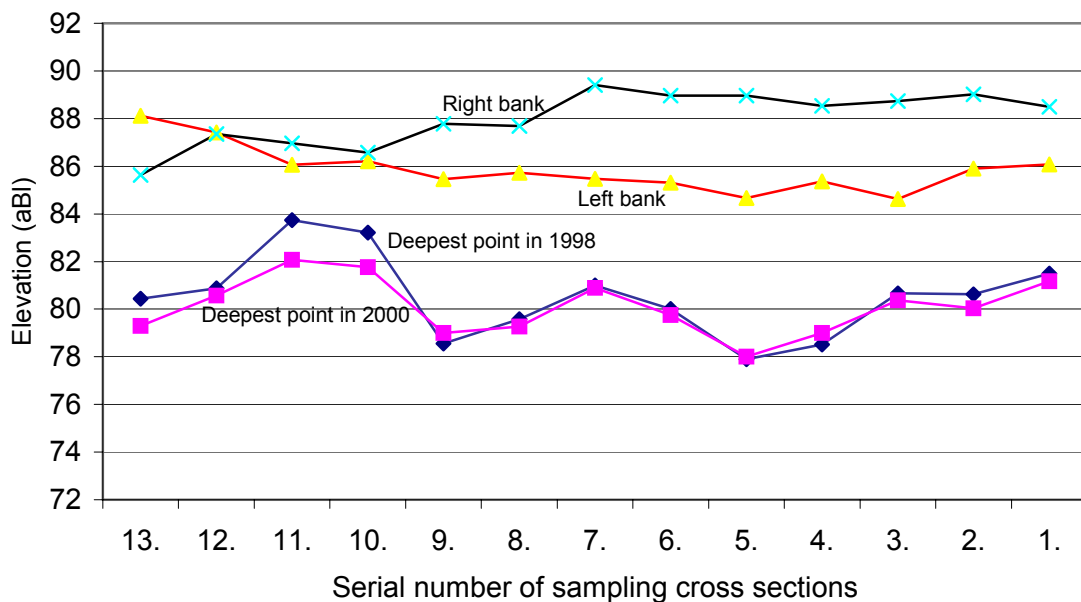
Figure 24. Longitudinal section of the Vén-Duna arm

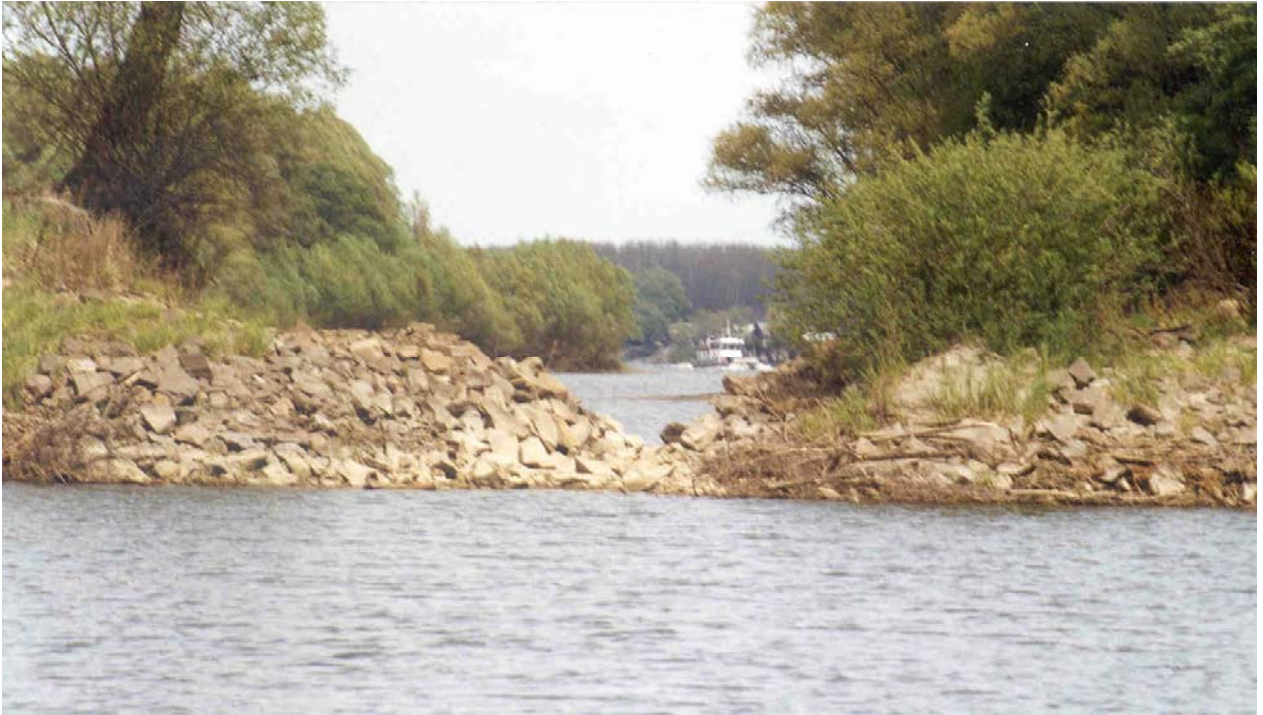
Photograph 1. The rock dam prior to the reopening, 1998 April

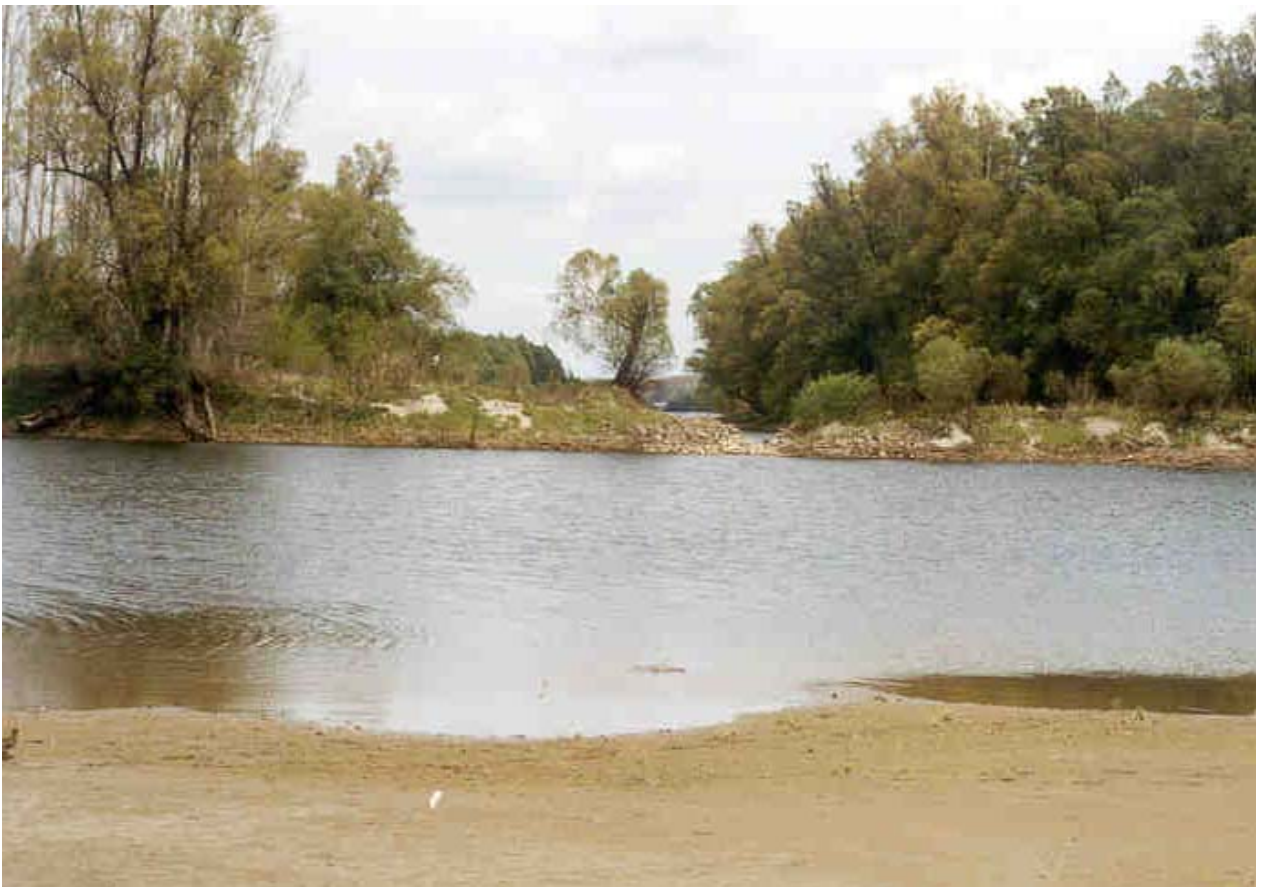
Photograph 2. An extended sand bar downstream of the rock dam, prior to the reopening

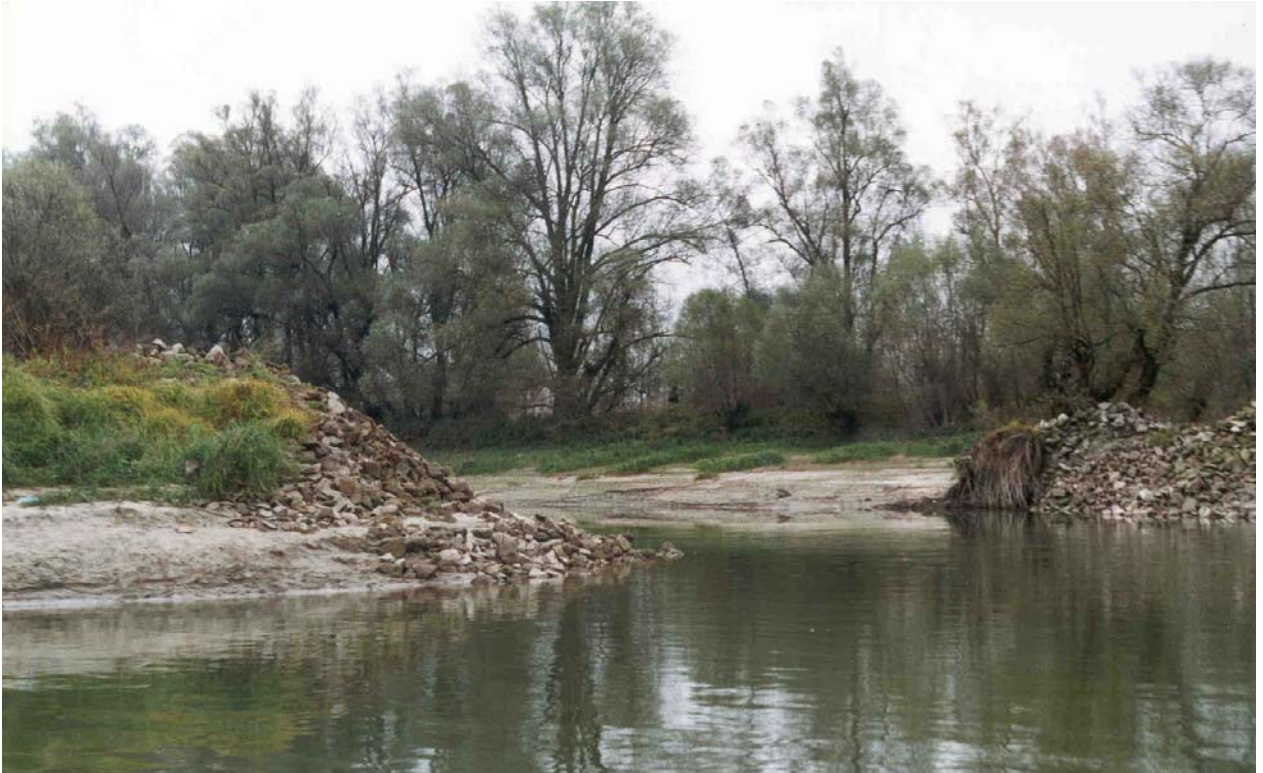
Photograph 3. The reopened rock dam

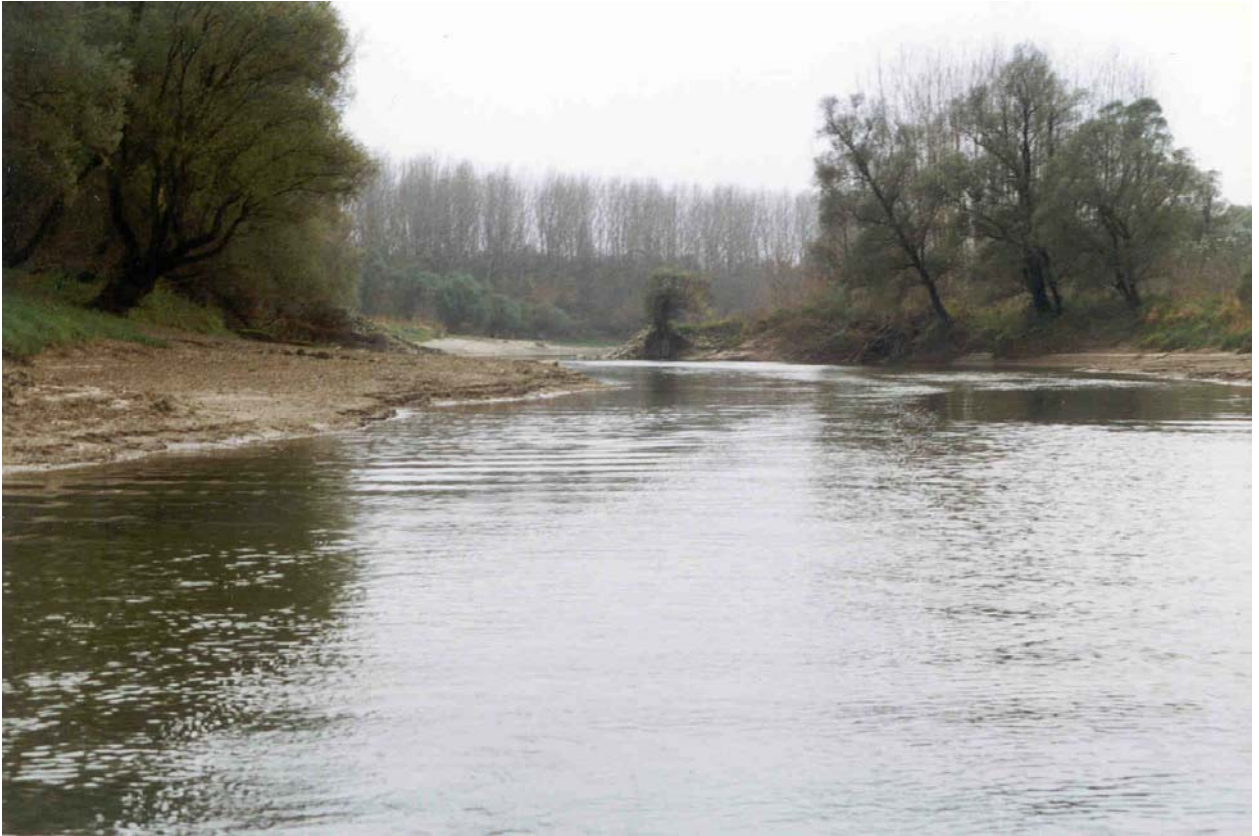
Photograph 5. The reopened upstream section indicating the dredged channel

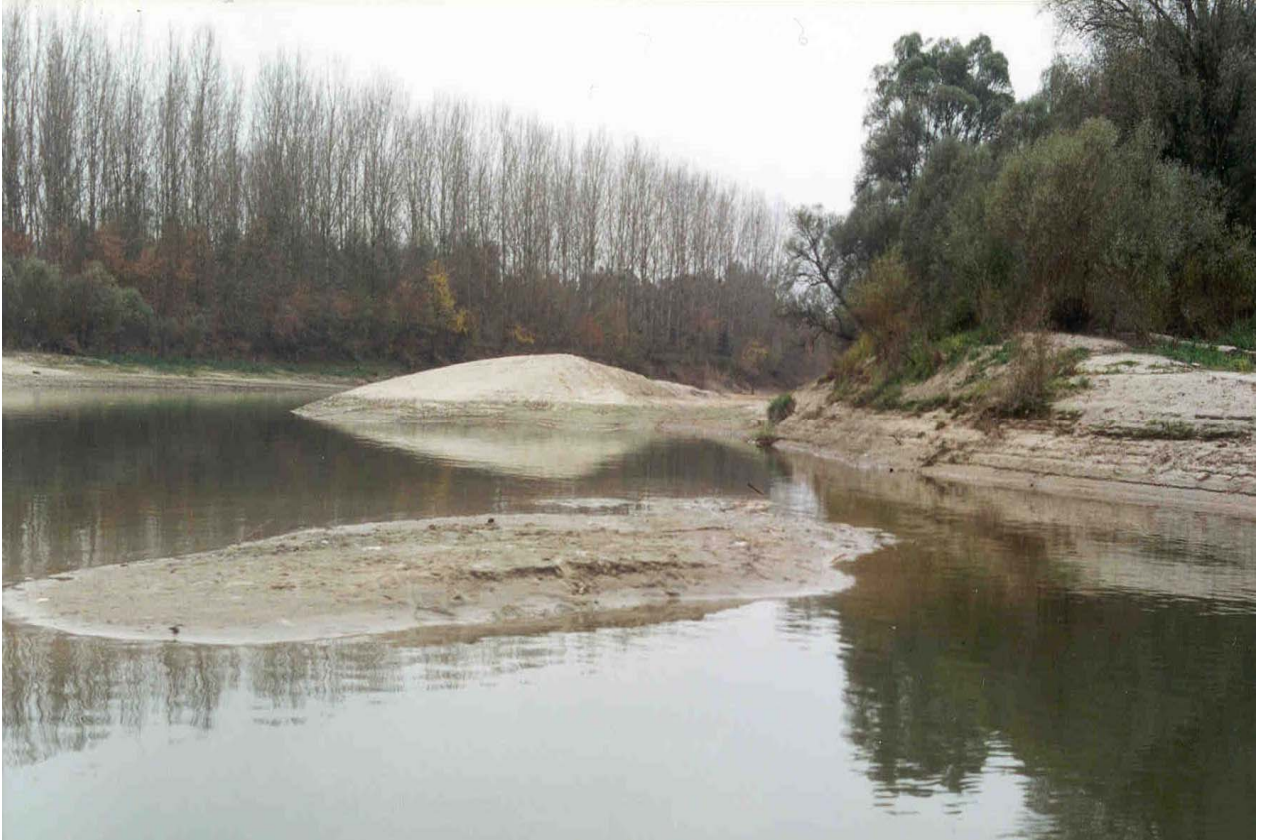
Photograph 7. The rearranged sand bar by the through flow after reopening

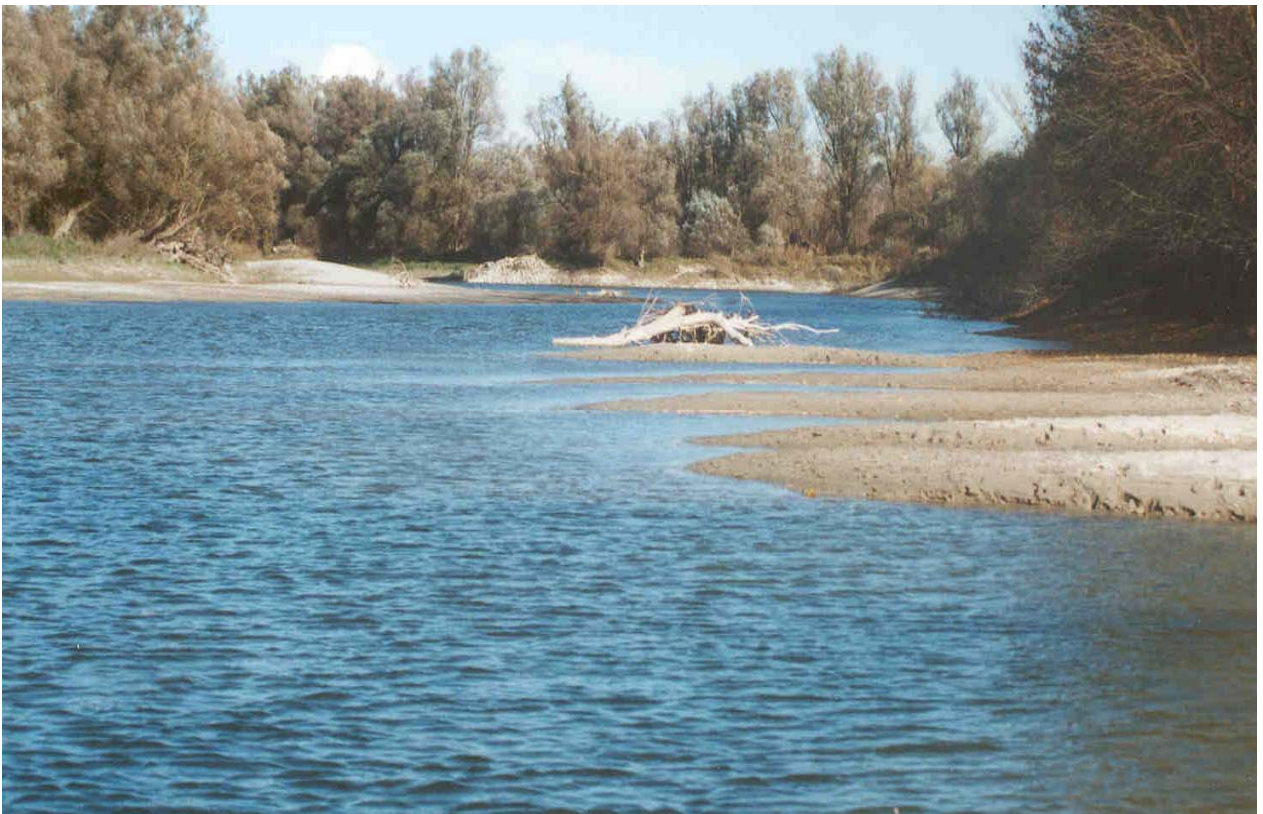
Photograph 8. The rearranged sand bar by the through flow after reopening from downstream view

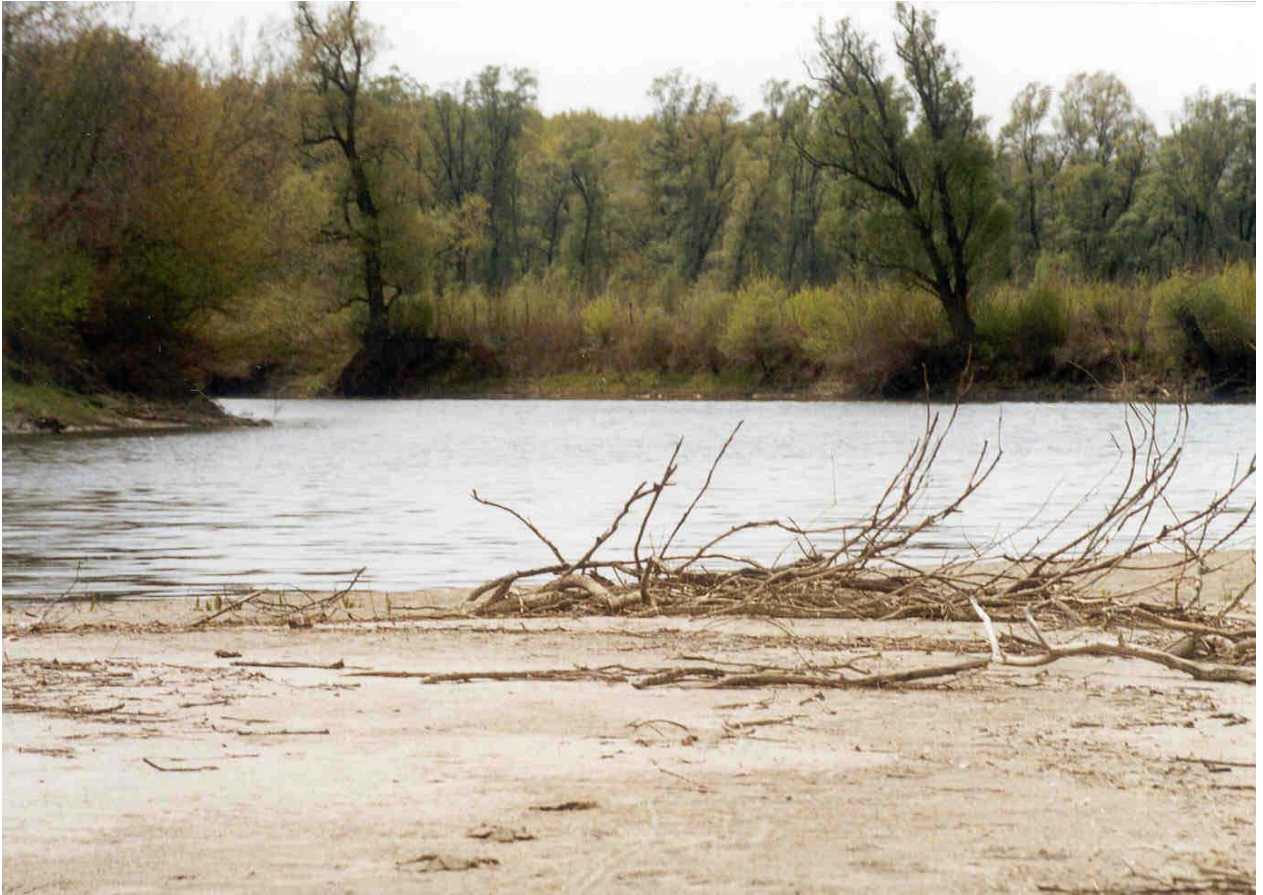
Photograph 9. Wooden debris washed away and deposited on the sand bar
