**THE MANZANARES RIVER RESTORATION (NORTHERN  
MADRID -SPAIN-): DEMOLITION OF AN OBSOLETE DAM  
AND RIVERINE ECOSYSTEM REHABILITATION**

<sup>1</sup> Confederación Hidrográfica del Tajo. Ministerio de Medio Ambiente, y Medio Rural y Marino

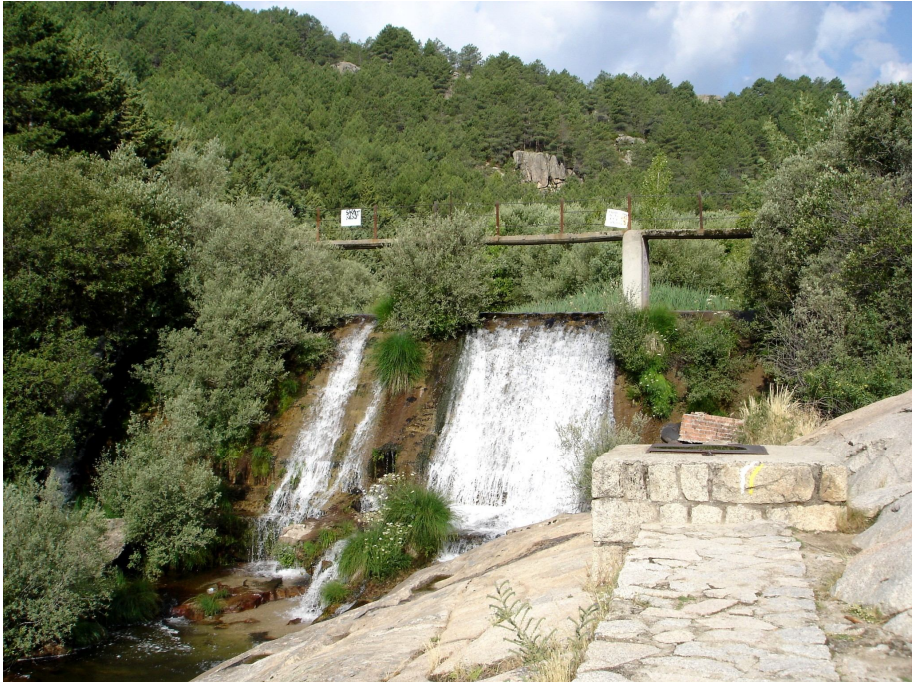
Figure 1 – Manzanares dam before the demolition

During the decade of the 40s, a small dam (9 meters high, 23 meters width) was built in the Manzanares river, in a site placed inside the Regional Park, in order to supply water to the village –Manzanares del Real- located few kilometers downstream. Year by year the dam has accumulated such a big quantity of sediments coming from the granite banks and slopes, that at the end of the century it was completely full of sand, in such a way that it became useless.

So, this abandoned dam full of sediments and partially damaged, turned into an ecological disaster that was the responsible of the decrease of natural values within the riverine ecosystem, a disruption of the longitudinal and transversal river continuity, a barrier for trouts and other species, a nutrients trap, an obstacle to normal flow and hydrodynamics, as well as a serious danger for the Park visitors if a sudden collapse may occur.

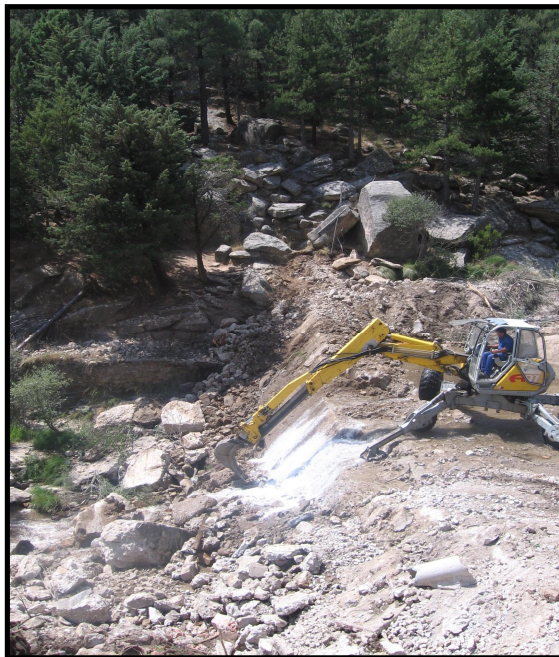
Figure 2. Mechanical digger

The works were carried out in three stages: in each one the target was the demolition of a part of the dam through different controlled detonations and then the masonry and sand removal. Once the detonations had split into big pieces the dam wall, it was necessary to obtain lower sized blocks in order to allow the helicopter carry them into big bags. This task was accomplished by a relatively small mechanical digger, which was chosen because of its “spider-legs” that could allow its access trough the river bed with minimum impact due to the reduced footholds. For this works 500 hours of spider excavator were needed to fill 3.500 bags (1.600m<sup>3</sup> of waste).

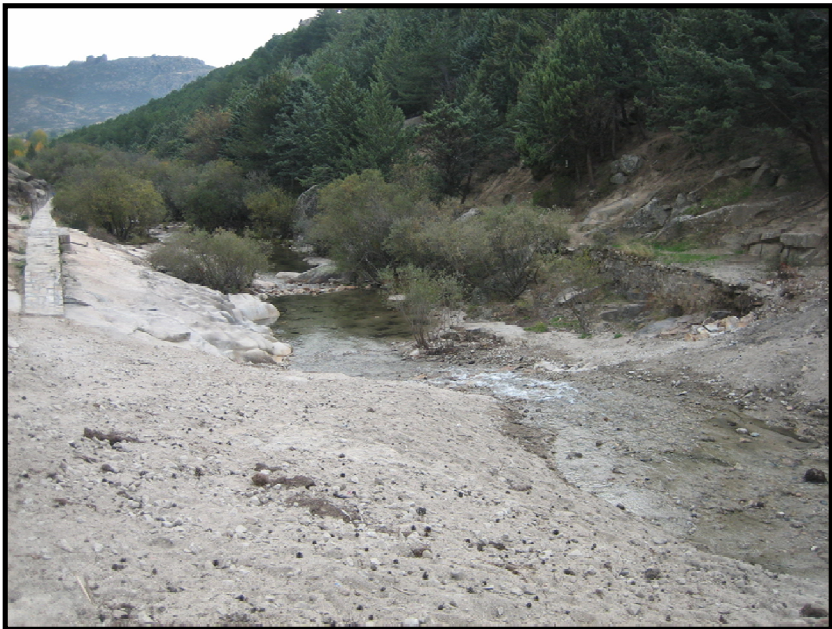
Figure 3 – Manzanares dam after the demolition

Finally, once the removal was achieved, the next goal was to restore the river bed and banks that had been affected by the dam -while existing- and the demolition works. During this stage the tasks were to remove and set out the sand in order to give more uniformity to the surrounding banks and ground were it was needed, as the river flow was able to remove the last sand particles that had been retained near the old dam. As well it was carried out a light reforestation to give more stability to the slopes and enhance the riverine vegetation recovery. And at the end were removed all the artificial elements that were used during the works, as metallic fences or others. For the whole works, since the very beginning till the end, were needed a total of 1.100 day's wage.

After several months of works and with the aid of the hydraulic dynamics, the Manzanares river has been able to regain the appearance, the longitudinal and transversal continuity and the ecological dynamic that it should have had if the dam wouldn't had been built.
